FIELD INSPECTION

Project Name:	Mountain Valley Pipeline	Inspector:	Matthew Grant
Inspection Date:	Wednesday, September 26, 2018	Project Contact:	Brian Clauto
Spread: Franklin County	Spread I	Weather (Wet/Dry/Rain):	Wet

FIELD INSPECTION PHOTO LOG

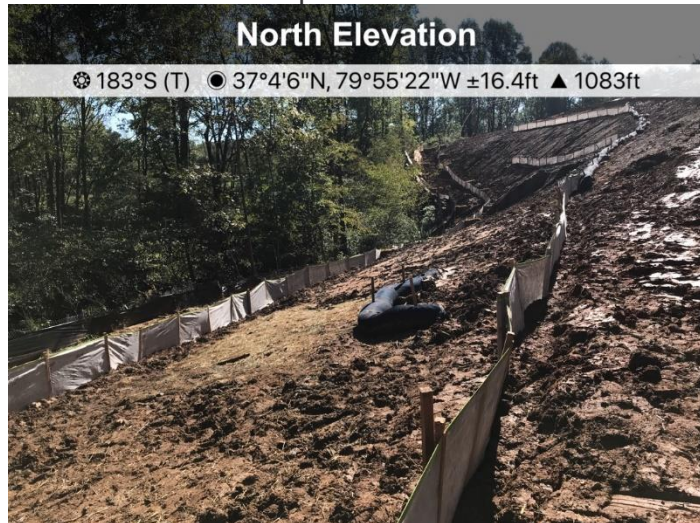
- **Area 1** – near MP 261 additional controls have been installed and escaped sediment has been removed where off site property permission has been given.

Fig. 1
Near MP 261 ECD in place

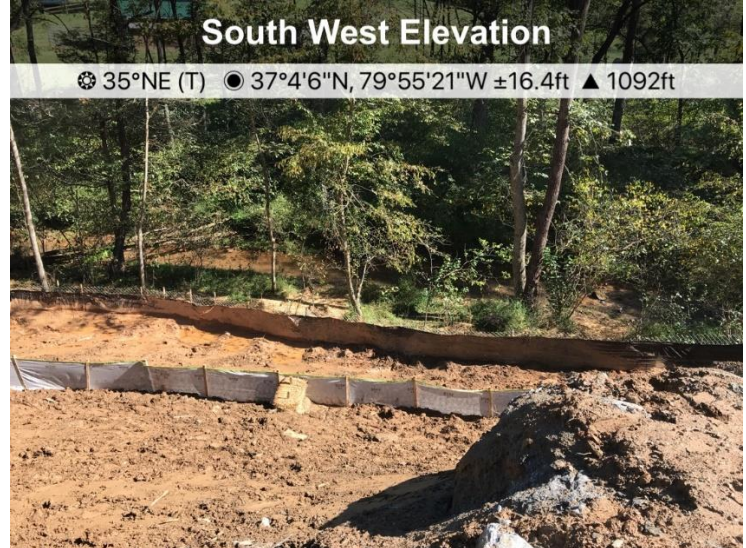
Fig. 2
Near MP 261 ECD in place

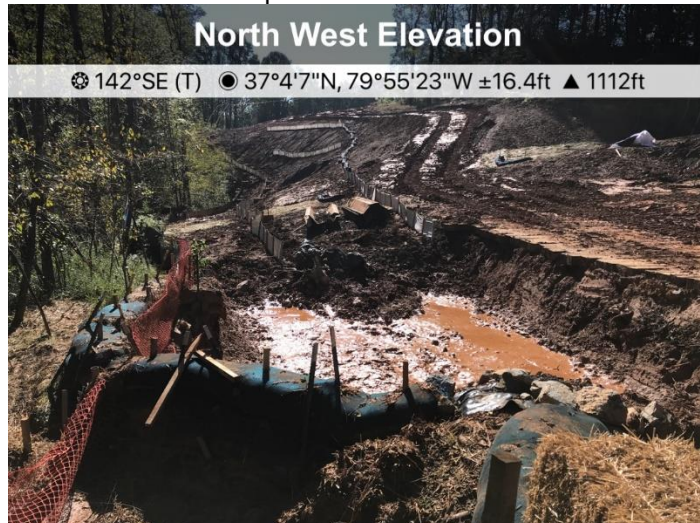
Fig. 3
Near MP 261 ECD in place

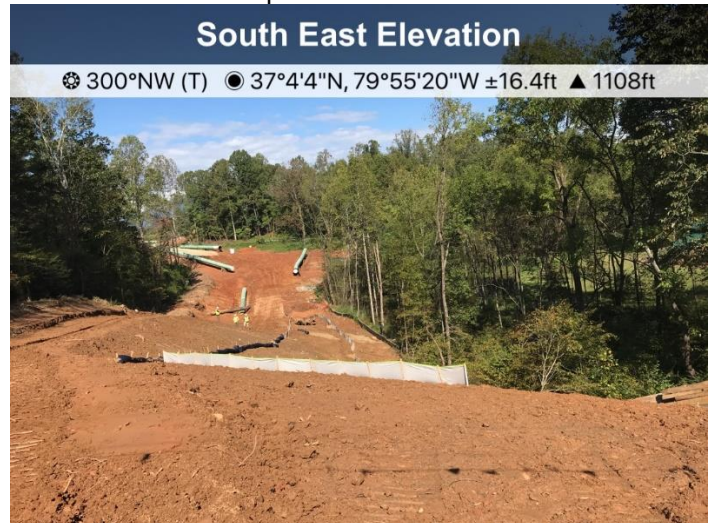
Fig. 4
Near MP 261 ECD in place
